Safe School Zone Program

Long-Term Outcomes

January 2020

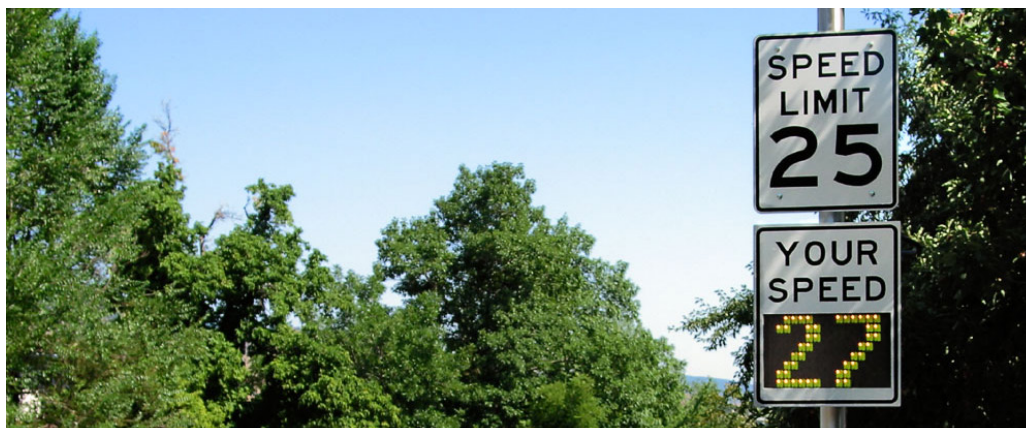
Figure 1.
Example of a
dynamic speed
feedback sign

To assess the impact of the project, the coalition worked with local police to perform speed studies at three locations near project sites before and after the improvements were made in the summer of 2012. Speed data collected in May 2012 were compared with data collected in December 2012 to assess the impact of the safety improvements. Data collected along N. Orchard Knob showed an average 85th percentile speed of 37.9 miles per hour and an overall average speed of 26.5 miles per hour before the school zone stencils and speed feedback sign were installed. Data collected after these improvements, in December 2012, showed that the 85th percentile speed decreased slightly to 36.7 miles per hour. However, the overall average speed increased to 31.4 miles per hour. On the Dodson Avenue corridor, 85th percentile speeds before the improvement were measured at 38.9 miles per hour, while the average speed was 34.3 miles per hour. After the school stencils were installed on Dodson Avenue, the 85th percentile speed was measured at 39.7 miles per hour and the average speed was 34.7 miles per hour, essentially showing no change between the two periods. The conclusions of the speed study indicate a desired reduction in the 85th percentile speed on the corridor where the dynamic speed feedback sign was installed, but the rise in the average speed may require further assessment to better understand its causes.

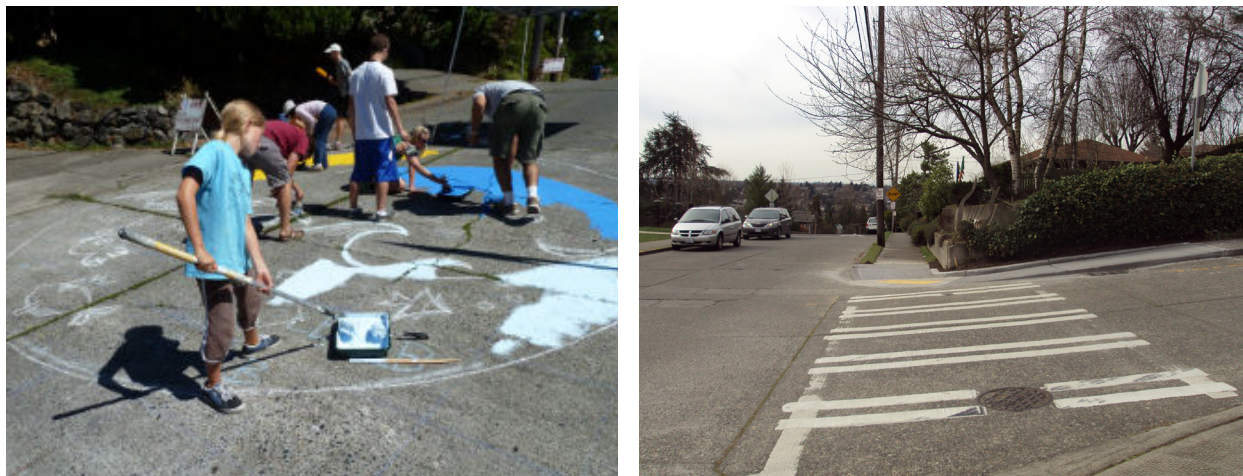
Figure 2. Students painting an intersection mural (left) and crosswalk improvements and curb ramp upgrades (right) near Graham Hill Elementary School

Safety improvements were planned and implemented on the school property and in the surrounding area. Those included speedbumps, curb ramp and crosswalk upgrades, and a painted intersection to calm traffic speeds.

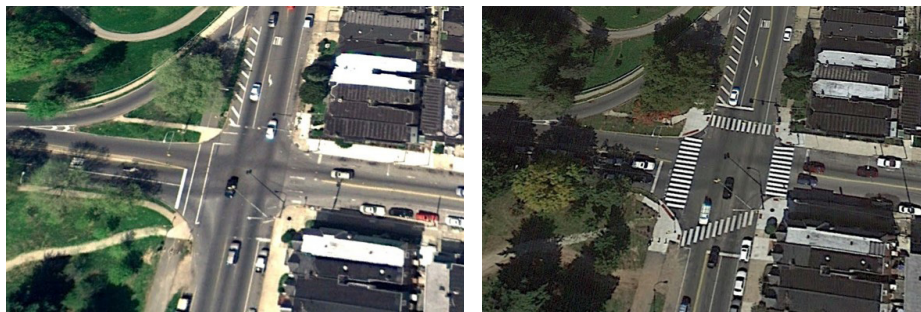
Figure 3. The intersection of Cobbs Creek Parkway with Marshall Road and Spruce Street before (left) and after (right) Safe School Zone improvements.

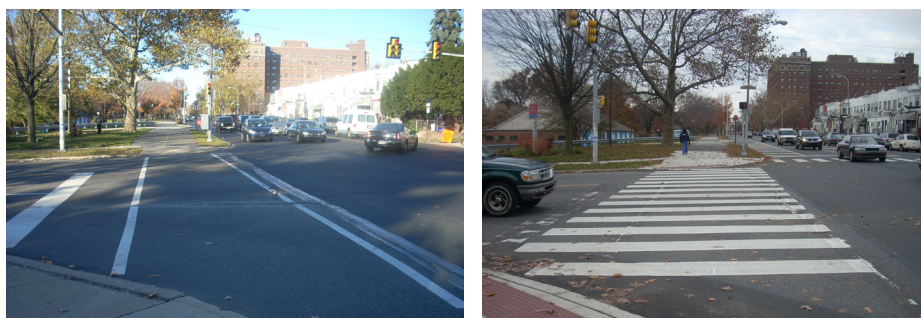
Figure 4. Ground-level view of the intersection improvements at Cobbs Creek Parkway and Marshall Road before (left) and after (right) changes were made.

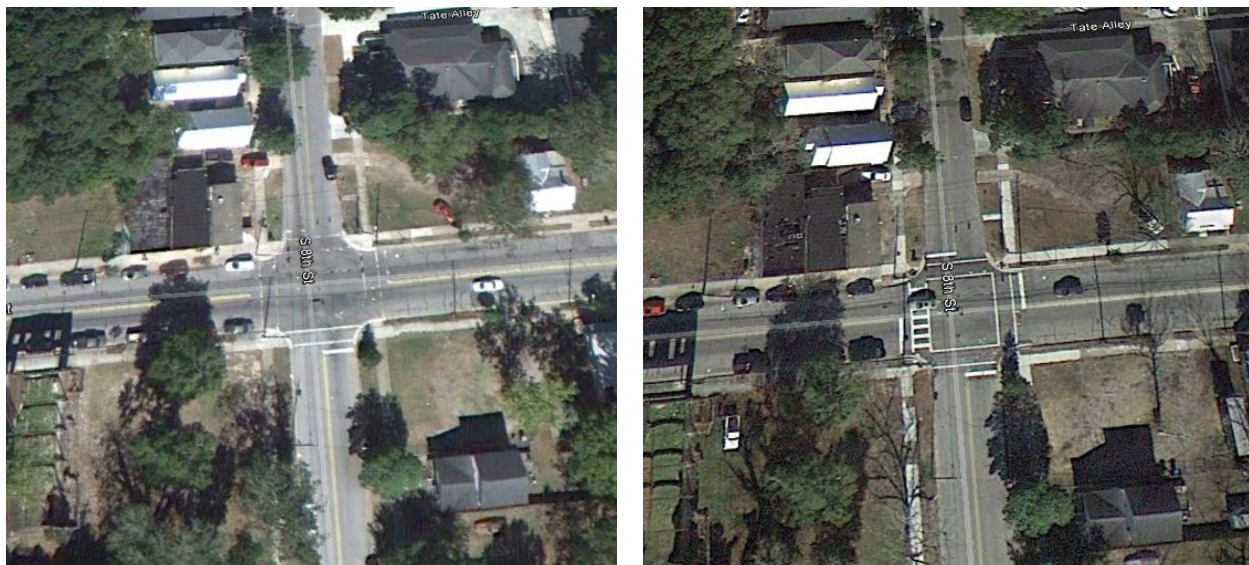
Figure 5. Aerial views of Castle Street and 8th Street before (Left) and after (Right) improvements were made

To improve conditions for pedestrians, both intersections received upgrades to curb ramps, as well as pedestrian signals and push buttons in the direction crossing Castle Street. As shown in Figures 5 and 6, the pedestrian push buttons, pedestrian signals, and high visibility crosswalk markings were focused only on one leg of the intersection, where most pedestrians had been crossing. This focus allowed the task force to make improvements at two intersections, instead of just one.

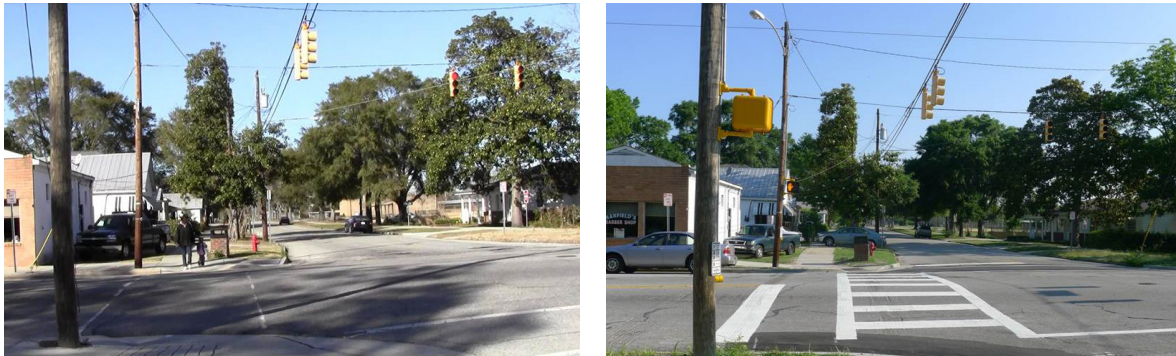
Figure 6. Ground-level view before (left) and after (right) changes at Castle and 8th

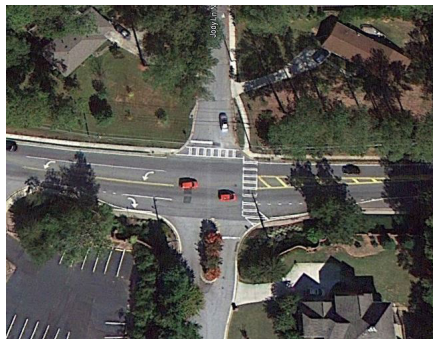
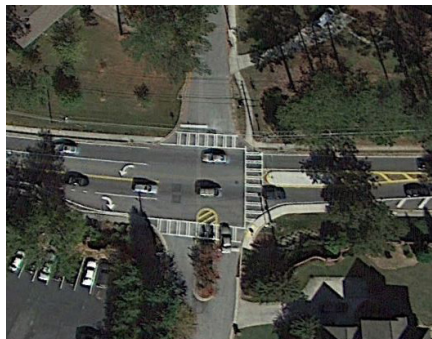
Figure 7. Aerial view of the Torah Day School project before (left) and after (right) improvements were made

The project site specifically experienced unsafe motorist behavior due to increasing traffic volumes at peak travel times. An acceleration lane from a nearby neighborhood was located at the school's primary crosswalk. The lane allowed vehicles to pass a left turning vehicle on the right, creating an additional lane of traffic at the site of the crosswalk. The lane can be seen in the bottom right corner of the image above.

The overall purpose of the project at Torah Day School was to improve the safety of pedestrians while crossing LaVista Road. There were several major environmental changes associated with this project, including a raised median, elimination of the acceleration lane, and the addition of a rectangular rapid flashing beacon (RRFB).

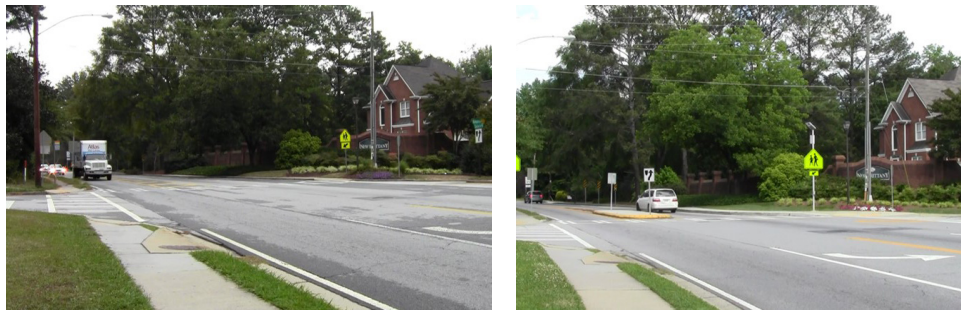
Figure 8. Ground-level view of the crosswalk at Torah Day School before (left) and after (right) the installation of the median, curb extension, and RRFB

Due to the length of the crossing, the task force decided to build a raised concrete median island where there was previously a painted median. This raised median would serve to eliminate illegal passing by motor vehicles, and to provide a refuge area for pedestrians who wanted to focus on crossing one leg of the crosswalk at a time.

Finally, the task force chose to install a system of RRFB signs on both sides of the crosswalk. These push-button activated beacons provide a high-intensity rapid flash indicator when the button is pressed, making the crosswalk more visible to approaching motorists. The signs replaced existing crosswalk signs.

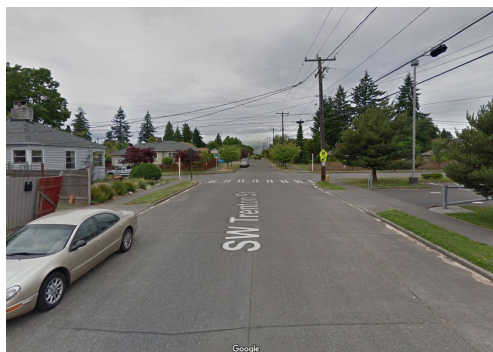
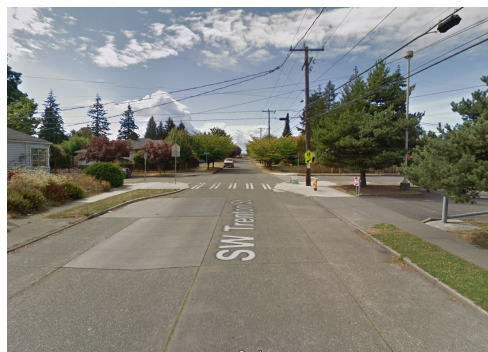
Figure 9.
Improvements at
SW Trenton Street
and 11th Avenue
SW before (left)
and after (right)
the project was
completed

In addition to the new crosswalks, two curb extensions were added to the intersection of SW Trenton Street and 11th Avenue SW. The primary reason for adding curb extensions was to shorten the overall crossing distance at this intersection and to improve pedestrian visibility at this crossing. The extensions allowed the pedestrians to begin their crossing in a more visible position, rather than crossing from behind parked vehicles.

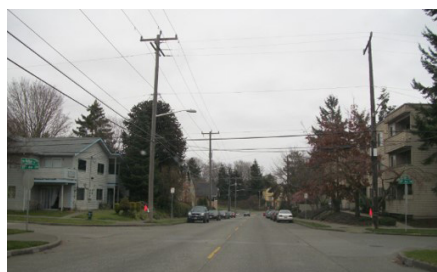
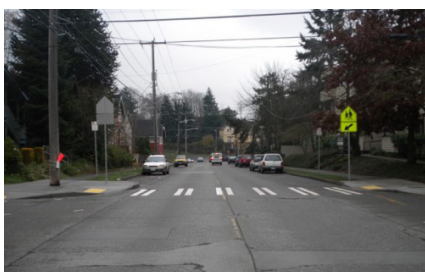
Figure 10. The intersection of SW Holden Street and 11th Avenue SW, located a distance away from the school, before (left) and after (right) improvements.

At the SW Holden Street at 11th Ave SW location, the primary improvement was the installation of a high visibility crosswalk along with upgrades to each of the curbs. On the north east corner, a curb extension was added to shorten the crossing distance across Holden and improve pedestrian visibility to motorists.

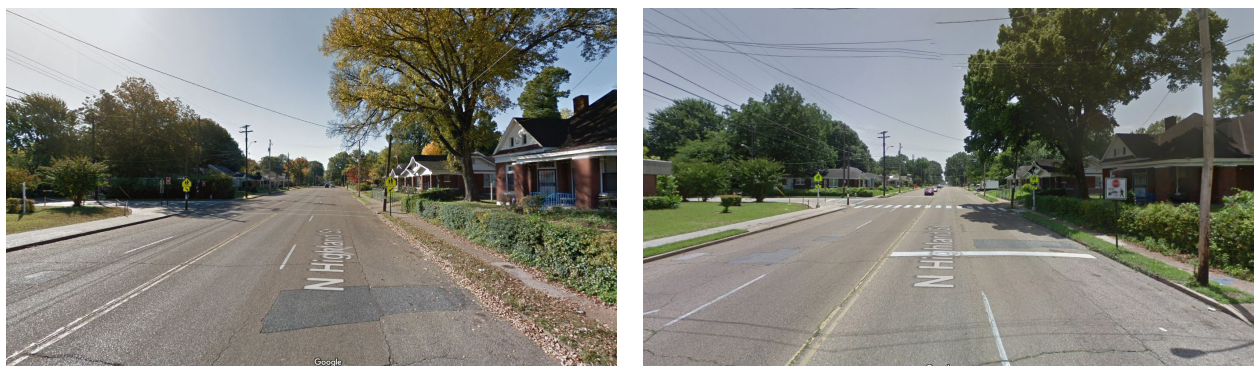
Figure 11. The view of the crosswalk at Highland Street before (left) and after (right) the installation of the RRFB system.

The primary improvements completed as part of this project were the upgrades made to two crosswalks across Highland Street. Each crosswalk was upgraded to a high visibility marking pattern, and Rectangular Rapid Flashing Beacons (RRFBs) were installed at each site. The RRFBs are push-button activated, stutter-flash systems that draw driver attention to the crosswalk when a pedestrian is attempting to cross. To help improve site distance and driver visibility at the site, supplemental pavement markings were installed to require drivers to stop ahead of the crosswalks when pedestrians are crossing. These advance stop bars reduce the risk of “multiple threat” crashes that sometimes occur when drivers pass other drivers who are yielding to pedestrians. By stopping further back from the crossing, visibility is improved and pedestrians are able to better determine whether drivers have stopped for them.

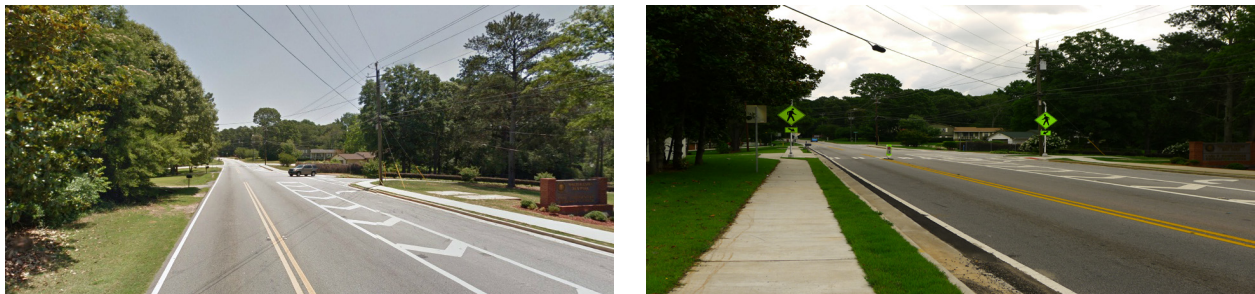
Figure 12. Street-level view of the reconfigured road and crossing before (left) and after (right)

As mentioned above, the project focused on establishing a crosswalk at the entrance to the recreation center to help facilitate foot traffic between the recreation center and nearby neighborhoods. A high visibility crosswalk was added at this location, complete with a push-button activated rectangular rapid flashing beacon (RRFB). The RRFB allows a pedestrian to push a button to activate a high-frequency stutter flash beacon that draws motorists' attention to pedestrians attempting to cross the street.

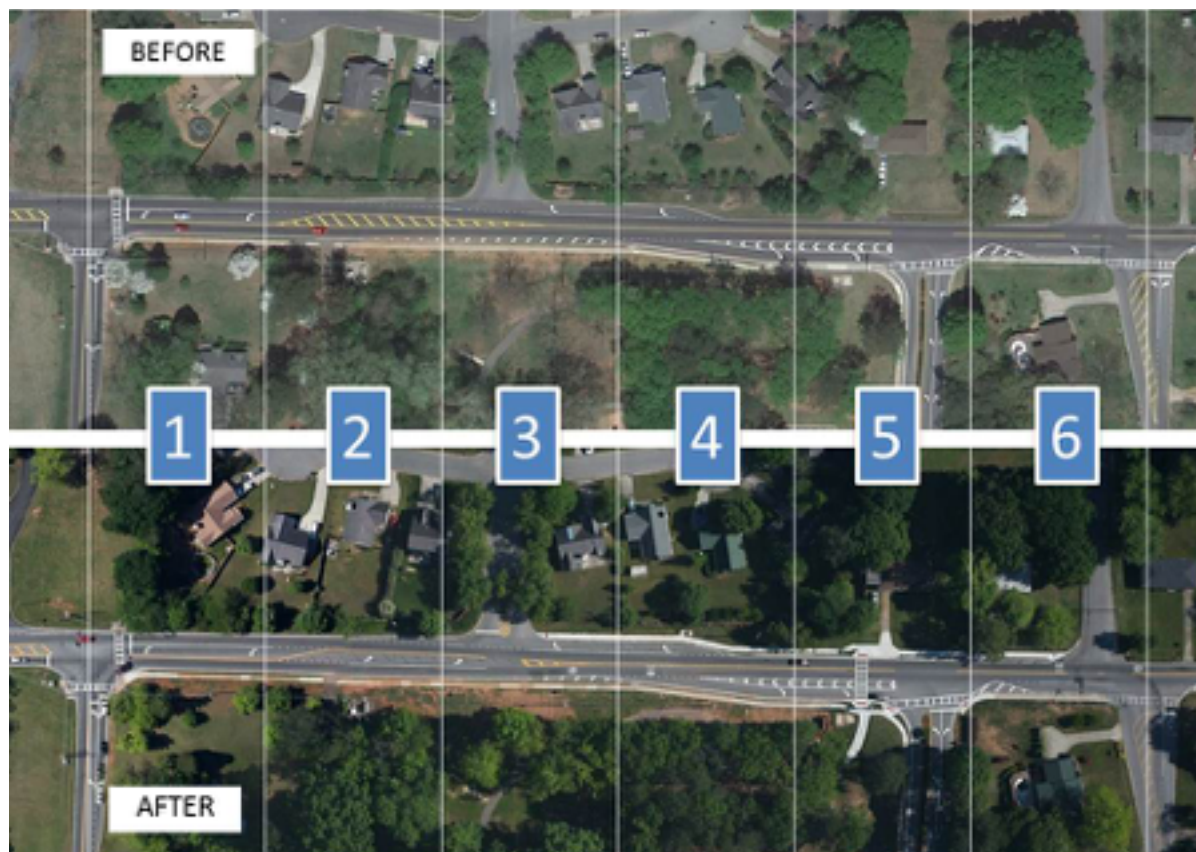
Figure 13. Map of zones used to assess pedestrian crossing locations and measure project impacts

To monitor pedestrian activities, staff divided the 0.20 mile corridor into six sections, each measuring 175 feet in length (as shown in Figure 13). Observations of pedestrian behaviors within each of those zones, specifically crossing location, were recorded during two days in the before period and two days during the after period. Data collection was conducted during the summer months when camps held at the recreation center increased the overall amount of foot traffic. Following an initial comparison of data collected before the treatment installation (July 2012) with data collected after the installation (July 2014), our team returned to the site in July 2018 to collect follow-up observations.

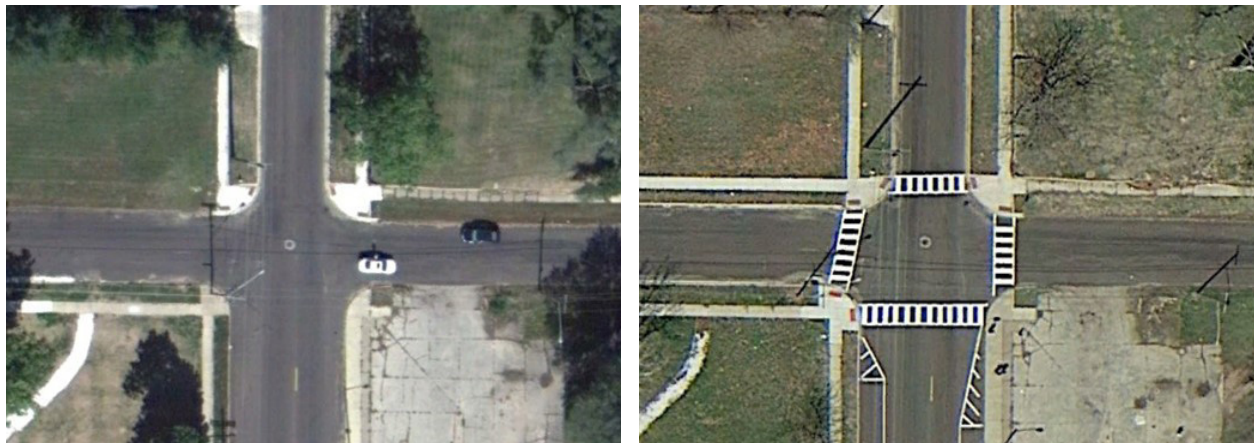
Figure 14. Aerial view of the intersection before (left) and after (right) improvements were made

To address these problems, the intersection was converted to an all-way stop by adding a stop control on the previously uncontrolled leg. Pavement markings were refreshed to increase the visibility of the crosswalks, and parking lanes were added using paint to help narrow the roadway and deter speeding.
